Fitting Instructions for Rovers North Mt. Mansfield Heater

Kits - MHKIIBE, MHKIIBL, MHKIICE, MHKIICL & MHKIII

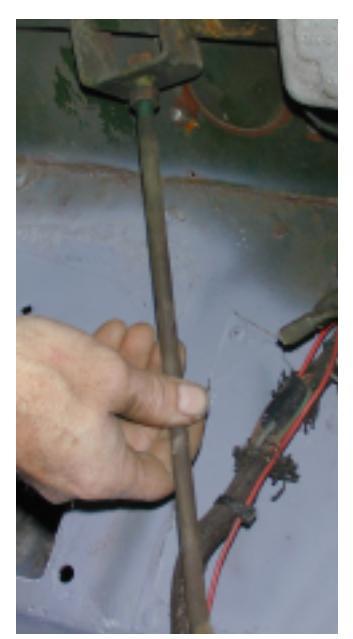
FIG. 1

- **Remove Old Heater Assembly** (*if equipped*). Step 3.
- Remove Support Rod (if equipped) from passenger side (right) Step 4. of bulkhead. (See FIG. 1)
- Cut Support Rod Bracket off of bulkhead from passenger Step 5. side but, do not remove any of the bulkhead! Make sure all of the bracket is gone - the Heater Core Box is very tight fitting. (See FIG. 2)
- Step 6. **Remove old splash guard.** If installing an MHKIICL or MHKIII, retain the splash guard for reuse. Kit MHKCE contains a new splash guard.

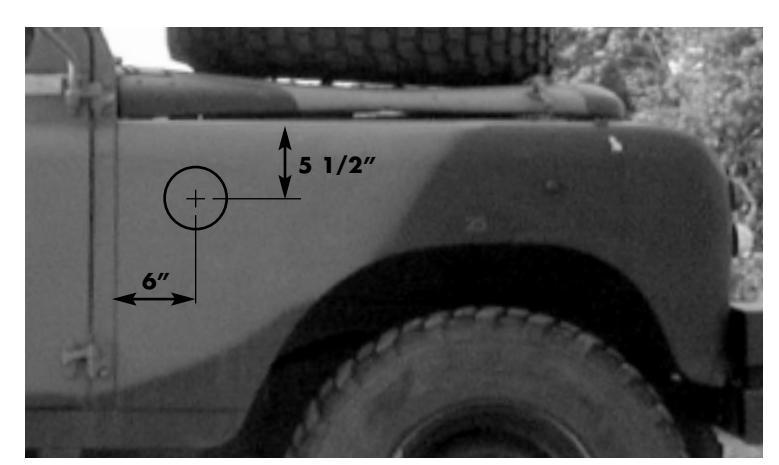
FIG. 3

Early Land Rovers need a hole cut into the passenger side wing. To locate this hole correctly, (See FIG. 3) measure 6" horizontally from the bulkhead to center of hole and 5 1/2" vertically down from the wingtop to center of hole. Mark hole 5" in diameter. TIP -> Make sure that the hole is exactly 5" in dia. as the air intake grill screw holes are very close to the edge of the 5" hole. (See FIG. 4) Hold the Air Intake Grill in place, and mark the three screw holes. Drill these holes with 1/8" bit. These holes will be very close to the edge of the 5" Air Intake Grill hole.

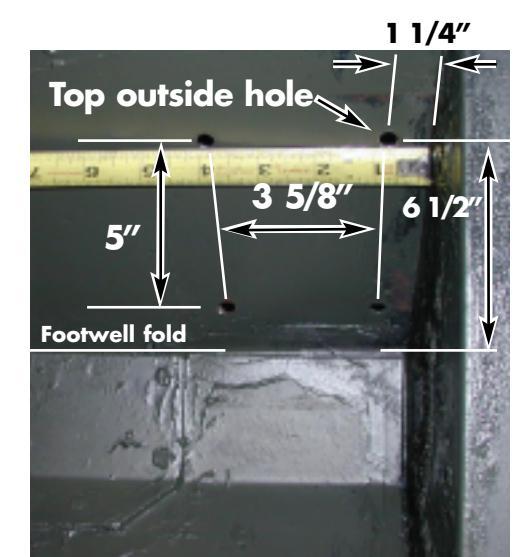
Mark the holes in the base and drill out with a 9/32" bit, as shown in figure 6. It may be necessary to move the blower unit inside the cab and mark some of the holes after a pilot hole has been drilled. *(See FIG. 5 for approx. bole locations)*

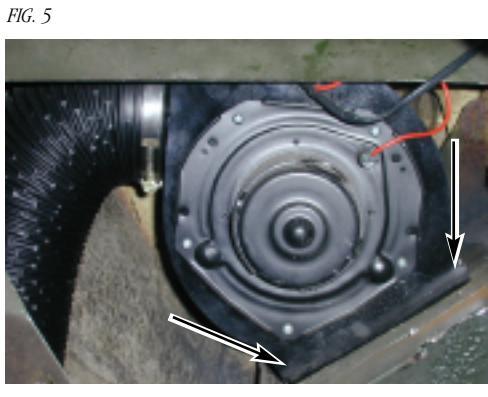
- **Step 9. Install the 4" air hose** over the output side of the blower unit. Use a 4" hose clamp to hold in place.
- **Step 10. Bolt in the blower motor assembly unit**, making sure the foam seal is properly placed over the air intake grill on wing. *Note: Extra washers can be used for shimming the blower assembly and the heater box. (See FIG. 6)*
- **Step 11.** If installing the MHKIICE, MHKIICL, *(see FIG. 7)* to mark the hole for the heater box. Drill out mounting holes and then caulk around the unit. Bolt the unit in place. For Series III (MHKIII) the heater box can be caulked and bolted in. *(See FIG. 7)*

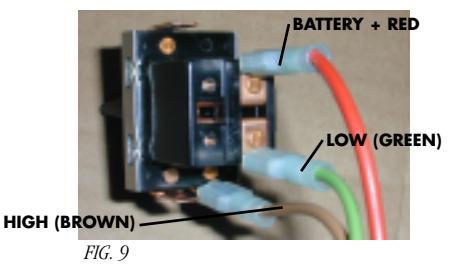
- **Step 12. Install the 4" output hose from blower** onto heater box using the 4" clamp. *(See FIG. 8)*
- Step 13. Connect Blower Wires to Heater Switch (See FIG. 9)

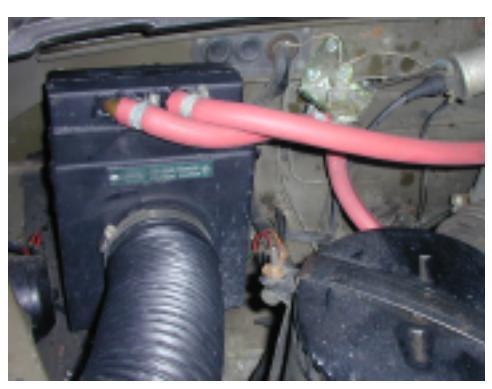
FIG. 10

- **Step 15. Install The Heater Hose:** By cutting the hose to the lengths needed and securing in place with clamps (*See FIGs. 10 & 11*). *It may be necessary to use the 2 nipples and copper washers on the engine head.*
