T H E S P E C I A L I S T S I N L A N D R O V E R S • U S A

RNA085 Defender

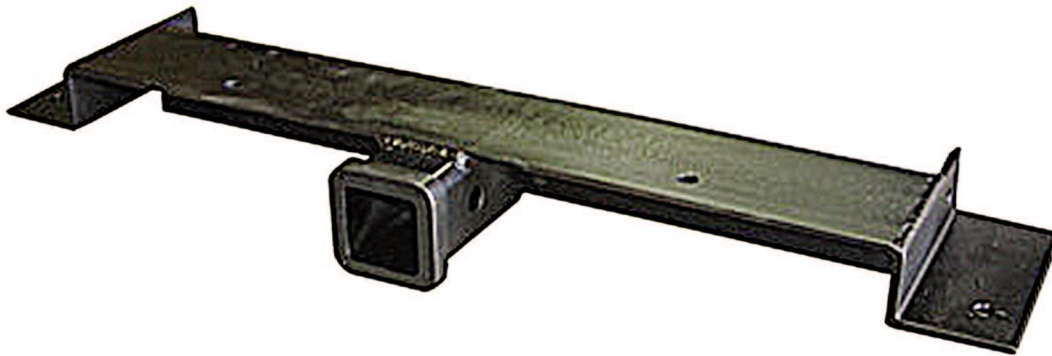
1. Remove both factory tie down rings located on the bottom of the chassis. Discard the rings.
2. Set the receiver hitch in place. Insert the bolts from the tie down rings to hold the in place, leave bolts loose.
3. Remove the rubber plugs from the front of each chassis horn. Locate the holes on the bottom side of the chassis horns. Install and tighten 2 of the bolts, nuts and washers (supplied) up through the holes. Tighten the tie down bolts.
4. Locate the 2 remaining holes in the receiver hitch and drill 7/16 holes up through the bumper, install bolts, nuts and washers. **Check all hardware for tightness!**
