Air to Coil Conversion Kit

How to convert your Range Rover 38A 4.0/4.6 litre (1995-2002)

Air Suspension to Coil Conversion Instructions

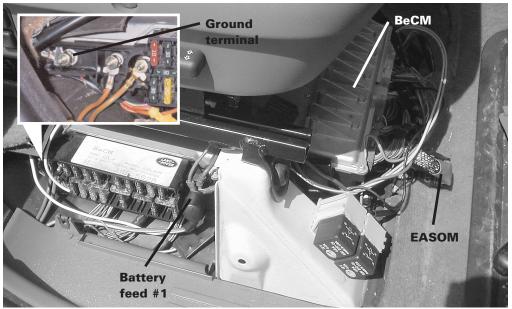
Figure 5 - Passenger side seat

- Disconnect the battery making certain to have the radio code first-see owner's manual.
- Remove the lower seat facia surrounding the right front seat: Remove the fuse door and the screw retaining the facia. (figure 5)

- 10. Remove the three fir tree nails securing the facia in place. This will expose the Body Electrical Control Module (BeCM) and fusebox. Looking at the Electronic Air Suspension Override Module (EASOM) replacement (figure 6), locate battery feed #1 (brown/pink wire) to the right of the fuse box and the ground feed to the BeCM, farthest to the left, or rear, of the vehicle. Locate connector, a green 20-way connector at the front of the BeCM (bottom row second one in on the left).
